Structural Audit Report of School Building of Kendriya Vidyalaya No.2 Uppal, Hyderabad

**NATIONAL INSTITUTE OF TECHNOLOGY
WARANGAL**

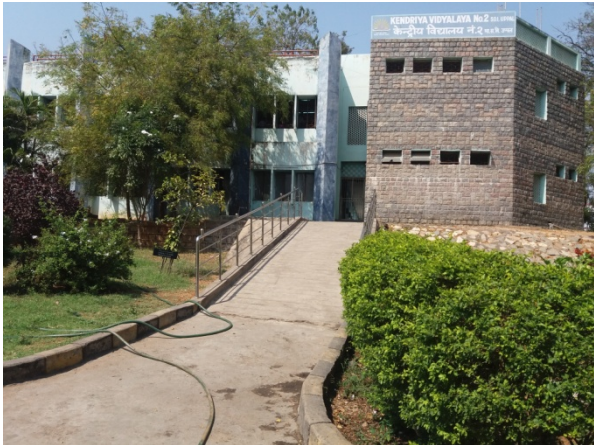
Fig 1 Stone Masonry Structure

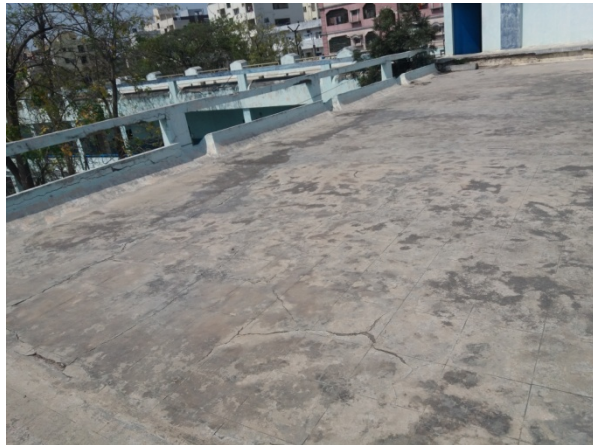
Fig 2 Cracking on the Slab Top

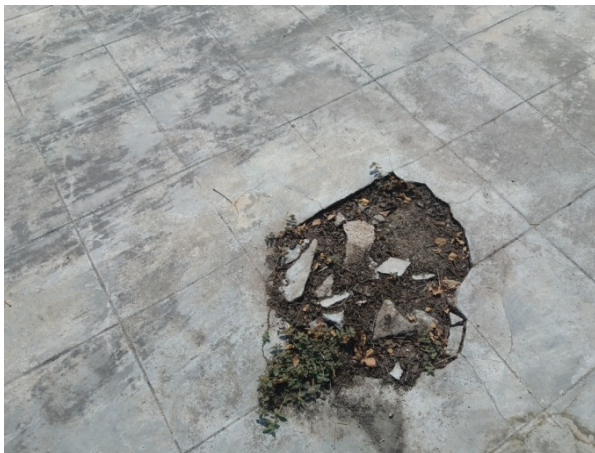
Fig 3 Delaminated Areas on the Slab

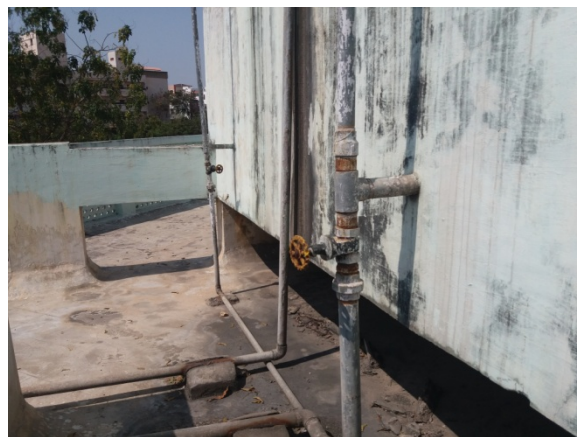
Fig 10 Corroded GI Pipes

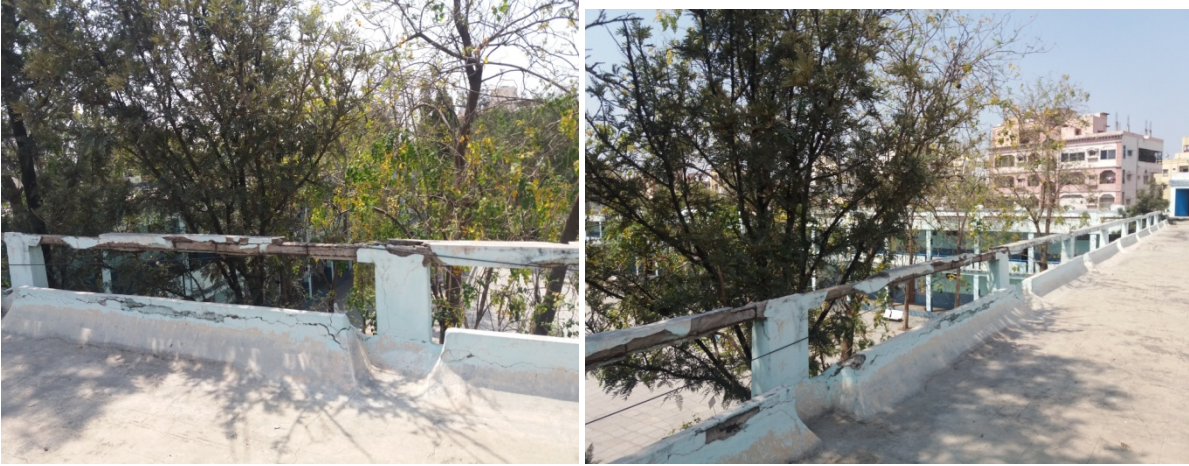
Fig 11 and 12 Corrosion of the railing of the Parapet Wall

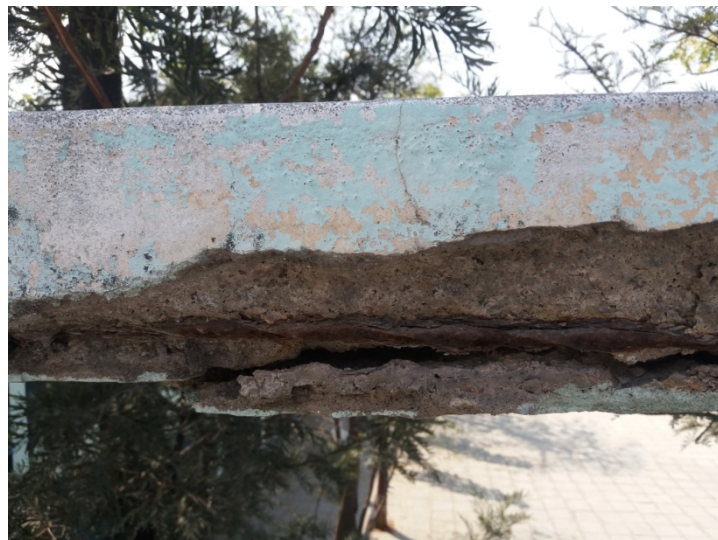
Fig 13 Loss of Diameter of Reinforcement-Severe Corrosion

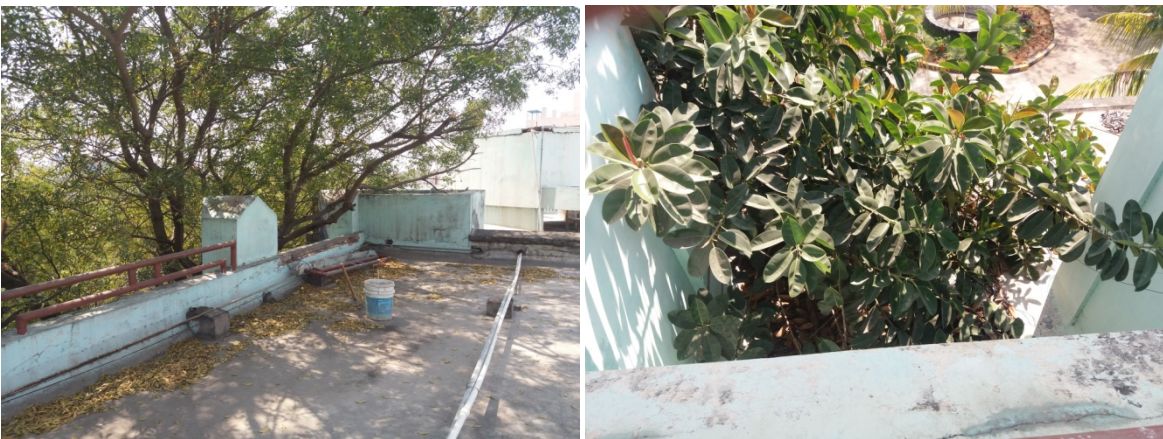
Fig 14 and 15 Invasion of Trees on the Building

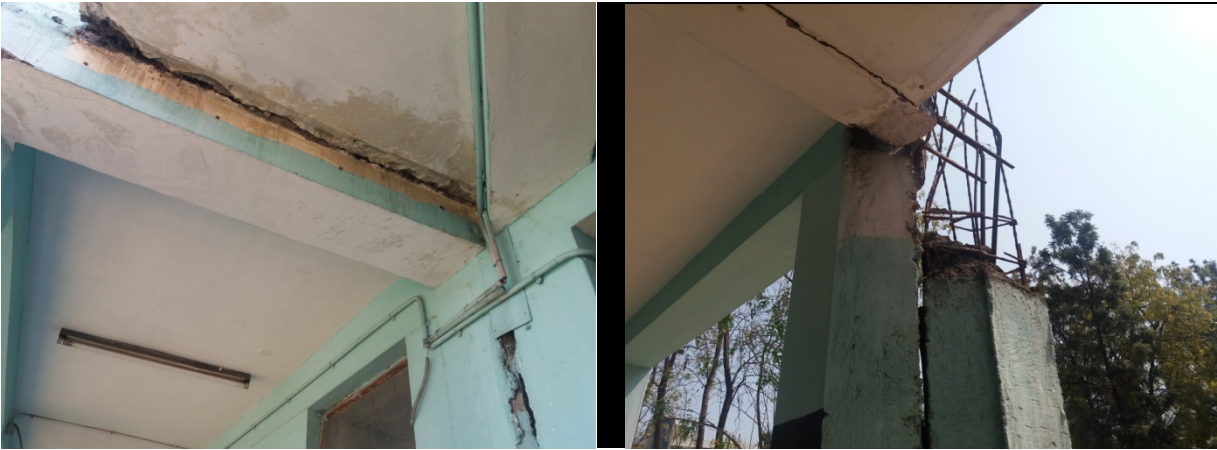
Figs 16 and 17 Expansion Joints-Leakage of Water from Roof Top/Floor above

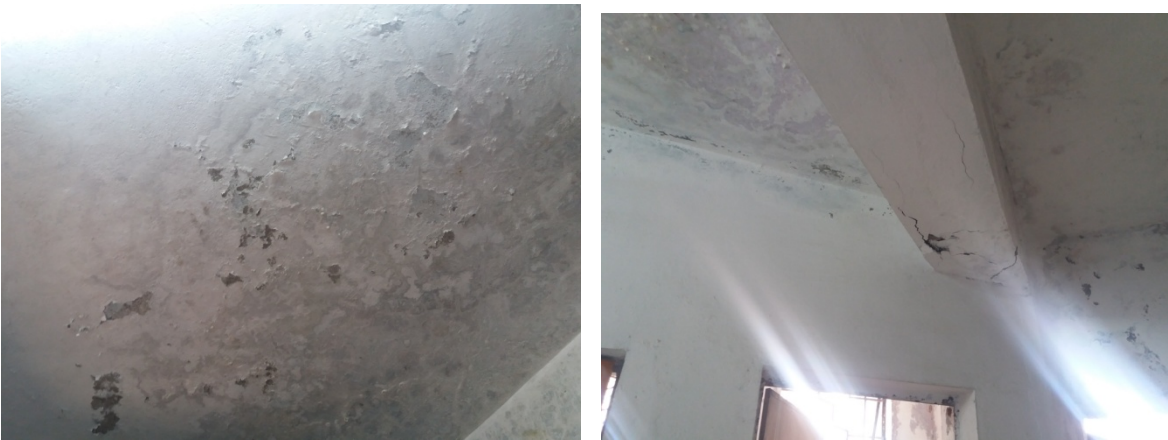
Figs 18 and 19 Dampness in the Slab due to septic water from the Toilets in First Floor

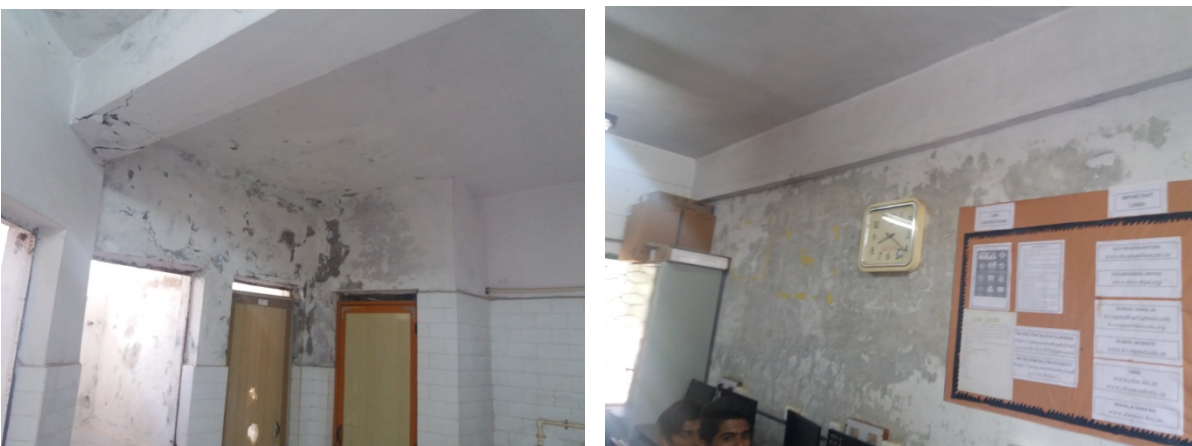
Figs 20 and 21 Dampness in the Walls
